Anomalous Free Field Recordings at Certain
Seismograph Locations

G. N. Bycroft

Open File Report

No. 8**2-**318

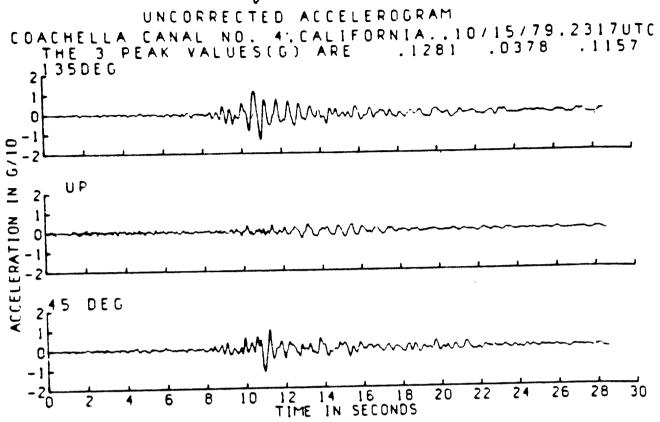
Fig 1

This case is more fully discussed in two other reports which describe a theoretical and an experimental investigation. Fig. 1 shows the recording obtained in the Coachella Engine House No. 4 of the October 15, 1979 Imperial Valley earthquake. A dominant 2 Hz frequency is seen in the three components. This is better shown in Figures 2, 3, 4 which show velocity response and Fourier amplitude spectra. As the engine house is a massive bunker-like structure located on a terrain of low shear wave velocity, soil-structure interaction appeared as a likely explanation. However, the experimental and theoretical study failed to show a 2 Hz frequency although the experiments agree well with the theory. This agreement is a good test for soil-structure interaction theory but does not explain these unusual records. It is possible that the close proximity of the canal is the cause or perhaps resonance in soil layers.

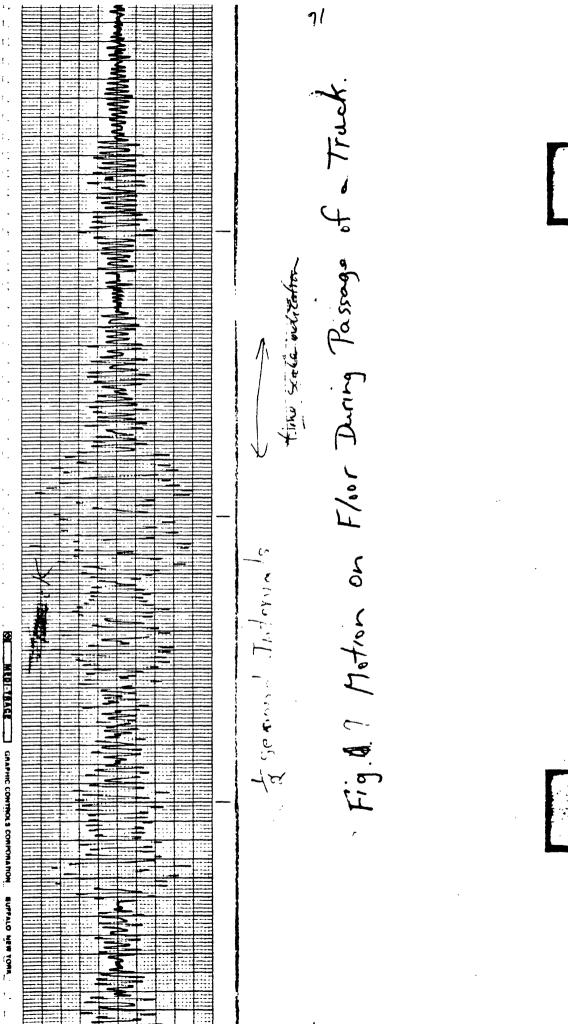
Fig. 7 shows the location of various instruments on the Island of Hawaii. A recording of the November 29, 1975 earthquake obtained at Honokaa is shown in Fig. 8 and consists primarily of a 7 Hz oscillation. This is a most unlikely accelerogram. The record obtained at Hilo showed none of this character. An investigation was made to find an explanation for this unusual record. The instrument is located on the concrete floor of the county service building in Honokaa. The building has a steel frame with corrugated iron roof and walls and is much too light for soil-structure interaction to be significant. The 6" thick concrete floor lies on 30" of crushed rock over 3 to 4 ft of top soil and then competent rock. The structure lies close to the edge of a small cliff at the bottom of which there is a road. Measurements of the noise level on the floor and at various points on the structure were made using a Kinemetric VM-1.

Trucks passing on the road below produced significant readings. Fig. 9 shows part of a record taken on the floor close to the seismograph location during the passage of a truck on the road below. A strong 7 Hz signal dominates the record. Thus it appear that this location is an unusual one in that an excitation produces an oscillation of 7 Hz. It is known that this region is permeated with large lava tubes up to 30 ft. in diameter and of considerable length. It is possible that these tubes form a structure having a 7 Hz natural frequency and that an excitation from any source will excite this frequency.

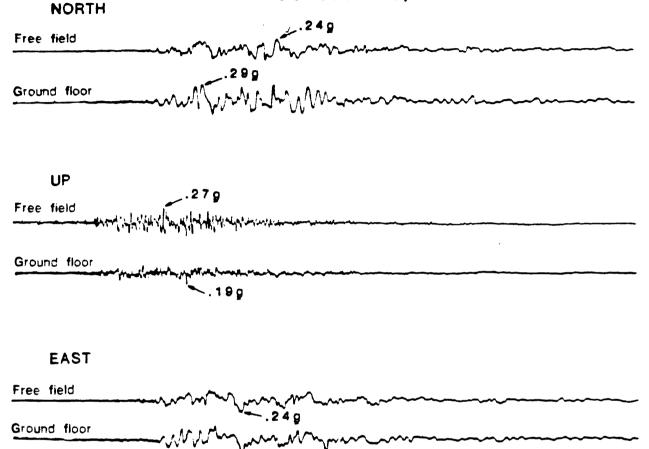
Figure # --October 15 acceleration-time histories recorded at Imperial County Services Building and adjacent free-field site.

The Imperial Valley County Services Building is instrumented and there is an adjacent free-field instrument. Fig. 10 shows the records obtained from the ground floor and the free-field site during the October 15, 1979 Imperial Valley earthquake. These records differ substantially and provide another example of soil-structure interaction. Caution must be exercised in assuming that the motion of the base of the structure is the free-field motion.

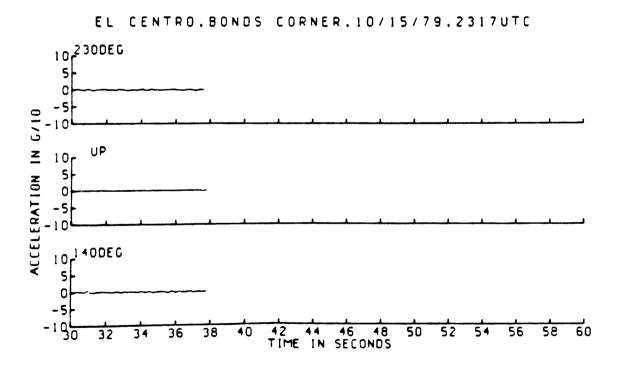
Fig. 12 shows the accelerogram obtained at Bonds Corner from the Imperial Valley Earthquake of October 15, 1979. In both the horizontal traces there is seen a series of spikes especially in the latter part of the record. These spikes are atypical and would not be generated by normal earthquake processes, but rather by some sort of impacting mechanisms. During the earthquake a heavy steel beam fell on to the steel cover protecting the instrument. Such an incident would satisfactorily explain a single spike, but not a series of spikes. Possibly after the beam fell on to the cover it continued to rattle around in some fashion. Impacting can also arise from a loose mounting but an inspection showed this not to be the case.
